North Central Regional Transit District

Americans with Disabilities Act (ADA)

Transition Plan

May 1, 2015

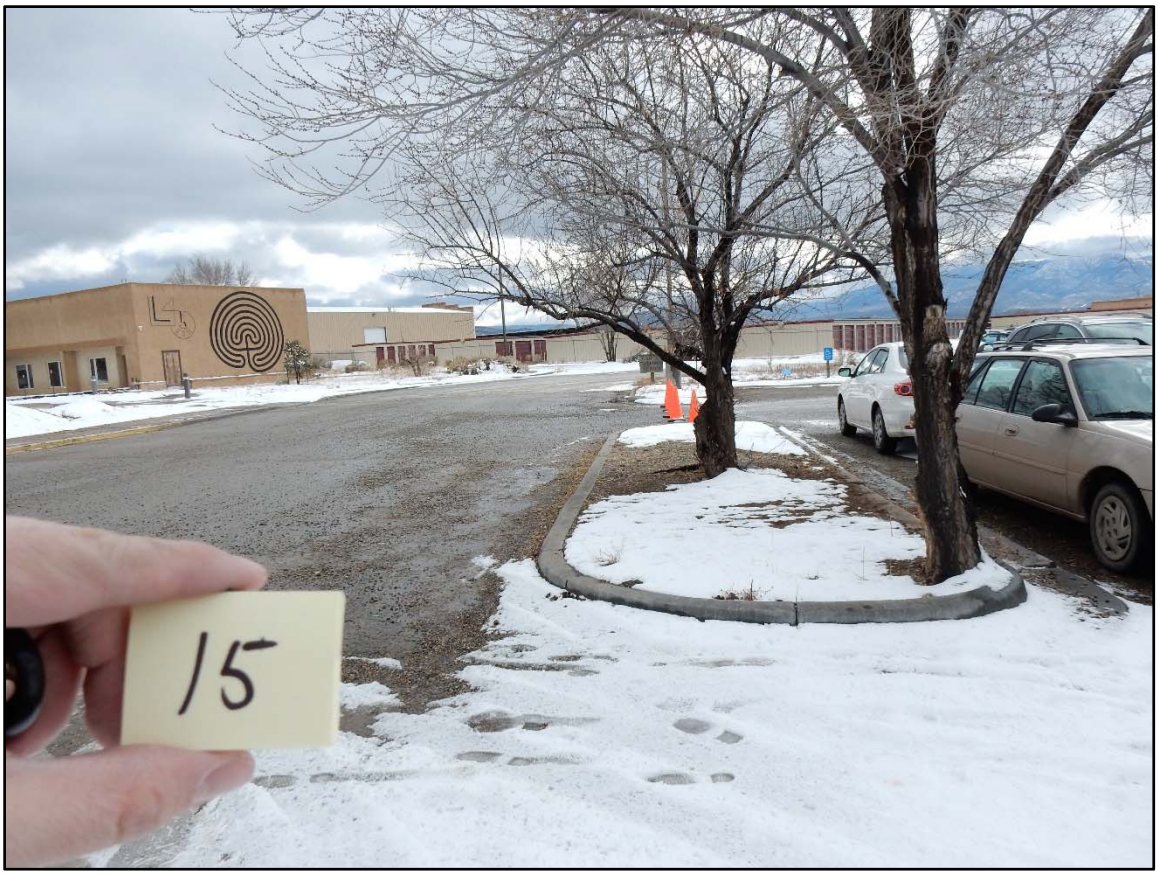
Route	Stop ID	Facility location	Connected to streets, sidewalks or pedestrian paths	Bus shelters connected by accessible route	Bus shelters min 30” by 48”	Bus stop boarding area steeper than 2%
Penasco_ Taos	15	Across the street from the EnSuenos Y Los Angelitos Development Center	Yes	No	No	Yes

Option	Easy to Implement
1	If detached sidewalk, fill in detached area	NA
2	Install pad on either side of shelter allowing 96” between curb and back of the pad	NA
3	Move the pad back allowing 96” for curb clearance	NA
